## INFLUENCE OF SEDIMENT TRANSPORT ON FLOW CONDITIONS IN THE VIDOCA RIVER WATERSHED, SÃO JOSÉ DOS CAMPOS-SAO PAULO-BRAZIL

Vendrame, I. F.<sup>1</sup> and Cunha, A.M.<sup>2</sup>

<sup>1</sup> Technical Institute of Aeronautics - ITA, São José dos Campos-SP-Brazil. E.mail : [hiria@ita.br](mailto:hiria@ita.br)

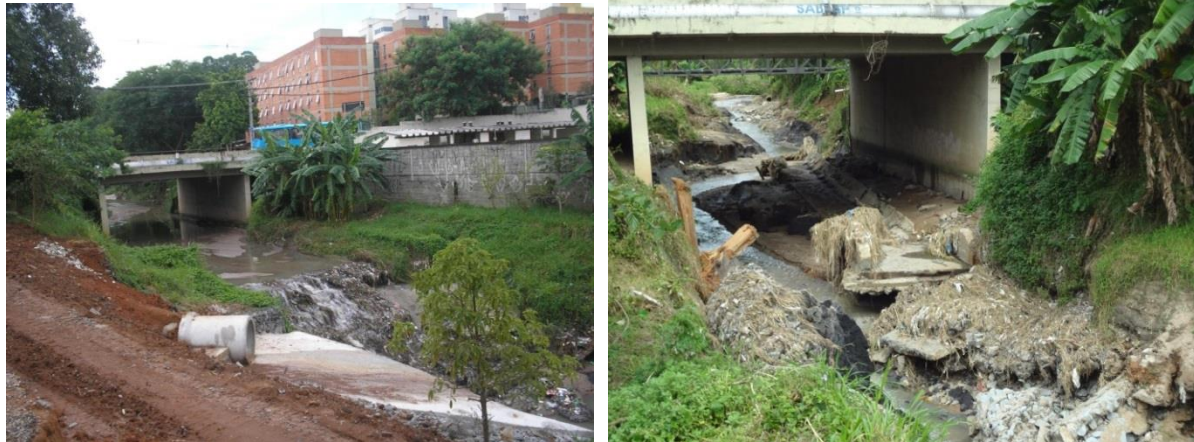
Figure 1.a - View of detention basin on Guadalupe Street, showing Senhorinha Creek, 05/03/2011.

Figure 1.b - Bridge on Guadalupe Street with damaged Senhorinha Creek showing the return of the stream channel to its original form, 23 Mar, 2013.

As a result, during the period 2000-2010, the bed of Senhorinha Creek was modified by the Municipality of São José dos Campos, by the installation of small retention basins along its route to reduce flooding problems and minimize deposition of sediments and silting beyond its confluence with the Vidoca River. Figure 1a shows the existing bridge on Guadalupe Street and repair work on the side slopes and stream detention basin located downstream from the bridge, on 5 March 2011. Figure 1b shows the same section shortly after the occurrence of heavy rain, on 23 March 2013, which resulted in damage to the structure of the bridge and caused a return to the bed's original features, destroying the existing detention basin at that site and leading to the fall of the bridge. Damage to this bridge because of the occurrence of heavy rains has been recurrent since March 10, 1999, the day that a rainfall of 102.7 mm occurred, causing damage estimated at 1.5 million reals in the Senhorinha basin, due the burning of power

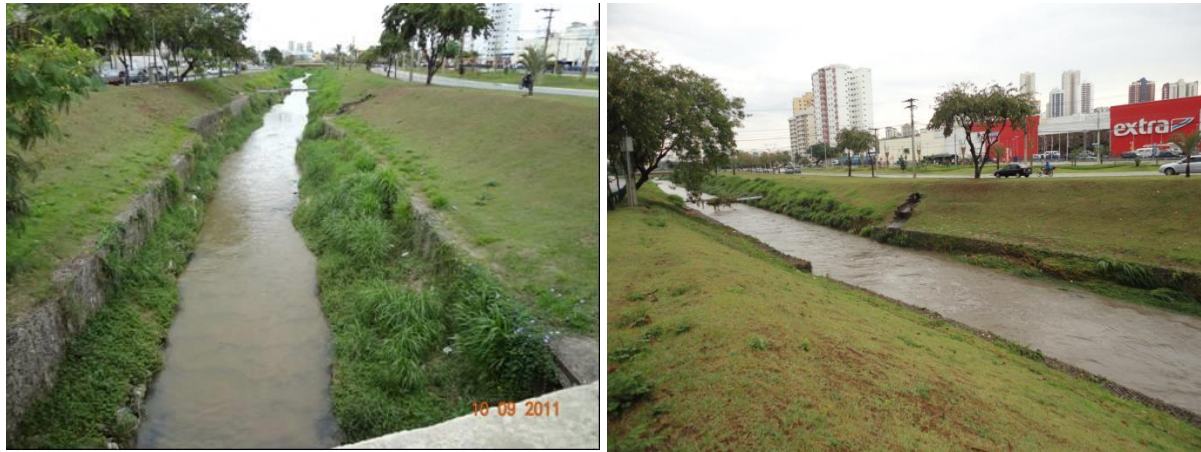
Figure 3.a - Banks and bottom of the Vidoca River at point P2.(10 September, 2011).  
Figure 3.b - Vidoca River at in section P2, showing urbanized area.(Cunha, Alessandra M.,2012).

In section P2 it was possible to perform a greater number of measurements, due to its ease of access, so its results are the ones analyzed in the present paper. The section is located 42 meters from the existing bridge at the intersection of Avenues Jorge Zarur and São João, next to Shopping Colinas in São José dos Campos and 50m from the mouth of its main tributary, Senhorinha Creek. As can be seen in Figures 3.a and 3.b, the banks consist of retaining walls in poor condition, a rectangular section to a height of 2 m, where there begins a slope with a gradient of 1:2.20 m, covered with grass. The vegetation in the summer consists of tall grass. The stretch upstream of the P2 section is straight. The staff gauge consists of three units with the maximum height at 2.70 m. In Figure 3.a it can be seen that the material at the bottom is quite sandy, but becomes compacted clay and organic clay near the center of the river, and there are also stones fallen from retaining walls in disrepair. The stretch located immediately downstream of the measurement section forms small sandy dunes along the bottom. Figure 3b shows the surroundings of the Vidoca River along section P2, on the left bank of the river. The surroundings are very urbanized, and the slope of the streets toward the river is quite pronounced.

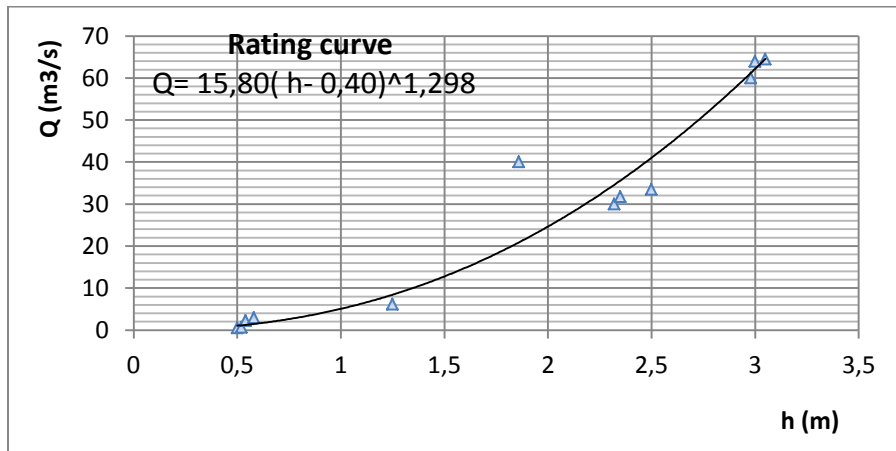
Figure 4 - Observed values of water level (h) and liquid discharge ( $Q_{Liq}$ ), for section P2, in the Vidoca River, São José dos Campos, São Paulo, Brazil, from Nov/2010 to Mar/2013.

Where:  $q_i$  are the flows in each catchment area  $A_i$  in which the wet section was discretized. Figure 4 shows the variation of the flows with the levels observed on the gauge. Equation 3 was fitted to the pairs  $h, Q$  with a coefficient of determination equal to 0.95.

$$Q = 15.80 (h - 0.40)^{1.298} \quad [3]$$

Where:  $Q$  is the liquid discharge in  $m^3 s^{-1}$  and  $h$  is the water level in m.

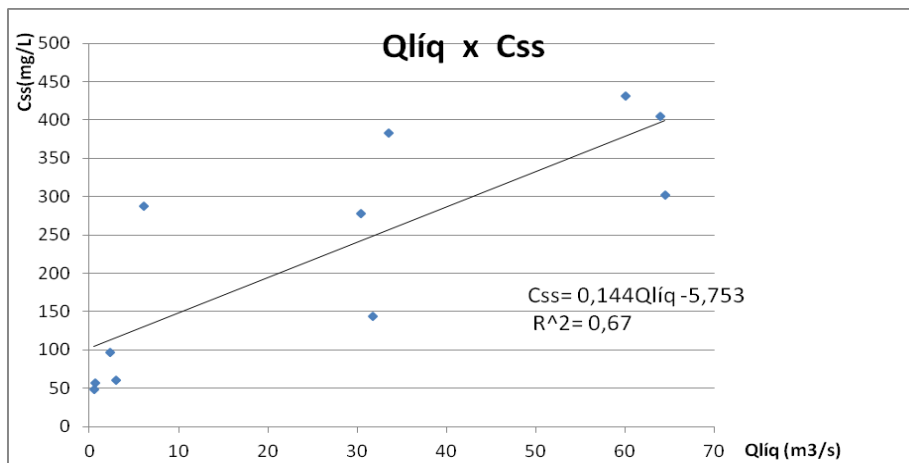
Figure 5 - Relation between observed values of liquid discharge ( $Q_{Liq}$ ) and suspended sediment concentration  $C_{ss}$  for section P2, in the Vidoca River, São José dos Campos, São Paulo, Brazil, from Nov, 2010 to Mar, 2013.

The relationship between liquid discharge and suspended sediment concentration is presented in figure 5. Equation 4 was fitted to the observed data at section P2 located in the Vidoca River, showing a linear

fit for  $C_{ss}$  vs.  $Q_{Liq}$  for those points. The point showing the largest sediment concentration, 2236.5 mg L<sup>-1</sup>, was disregarded in this analysis since it was considered an outlier. A linear equation represented the best relation between liquid discharge and suspended sediment concentration and gave a coefficient of determination equal to 0.67.

$$C_{ss} = 0.144 Q_{Liq} - 5.753 \quad [4]$$

The suspended sediment concentration, however, tends to reach a saturation value indicating that this linear relationship has an upper limit. From Figure 5, it can be seen that the four highest suspended sediment concentrations occurred in the months of January and March of 2013 because the monthly total precipitation for March of 2013 was higher than the average precipitation over the previous nine years, as shown in Figure 6.

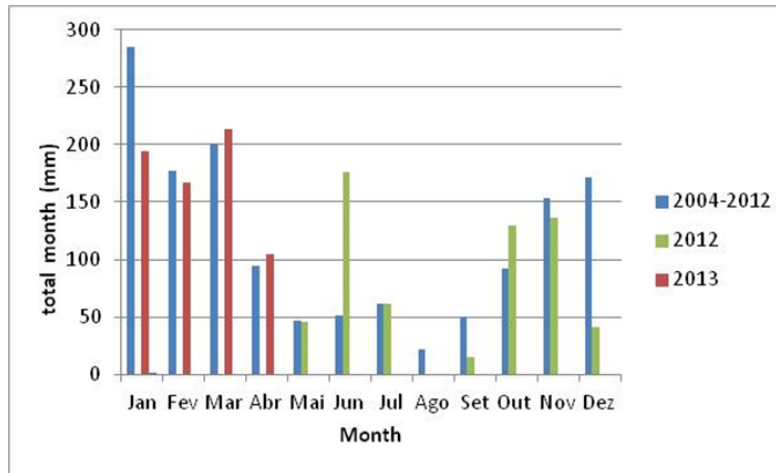
Figure 6 - Mean monthly precipitation(mm) for the period 2004-20012 and precipitation registered for the months of May to December of 2012 and January to April of 2013, at the meteorological station at INPE, São José dos Campos-SP, Brazil.

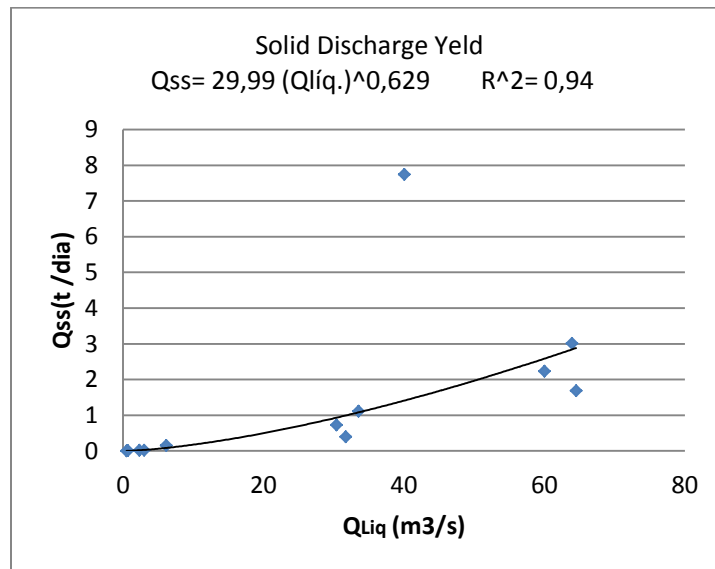
Figure 7 -Yield sediment curve ( $Q_{ss}$  vs.  $Q_{Liq}$ ) at section P2, in the Vidoca River, São José dos Campos, São Paulo-SP, Brazil, from Nov,2010 to Mar,2013.

The sediment yield curve was obtained, relating liquid discharge ( $Q_{Liq}$ ) to solid discharge ( $Q_{ss}$ ) data as shown in Figure 7. The best sediment yield curve fitted to the data collected in section P2 in the Vidoca River is an exponential equation (Equation 5) for which the coefficient of determination was equal to 0.94.

$$Q_{ss} = 29.99 (Q_{Liq})^{0.629} \quad [5]$$

Where:  $Q_{ss}$  is the solid discharge in  $t \text{ day}^{-1}$  and  $Q_{Liq}$  is the liquid discharge in  $m^3 \text{ s}^{-1}$ .
