EFFECTS OF CLIMATE CHANGE ON FLOOD RISK AND SUSTAINABLE DEVELOPMENT IN SOUTH AFRICA

P.M. Kundu¹, R.L. Singo¹, J.O. Odiyo¹ and T.R. Nkuna¹

1. *University of Venda, Department of Hydrology and Water Resources*

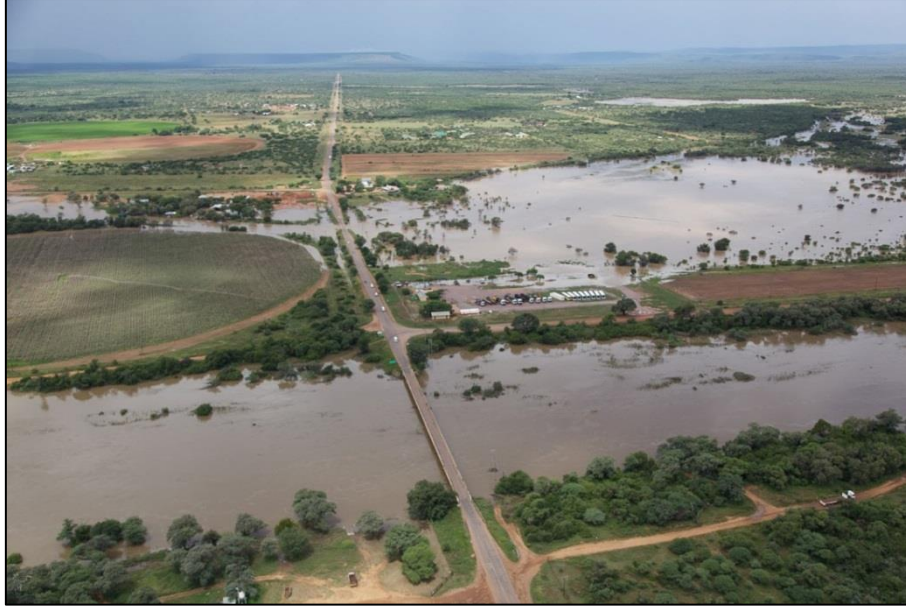
Figure 1: Floods at the Coal mining Town of Lephalale in Limpopo Province

South Africa's geographic location places it in the region of the world that is most vulnerable to both climate variability and climate change (IPCC 2012). The social and economic costs of climate change are a growing threat to the achievement of sustainable development. There were 539,811 deaths, 361,974 injuries and 2,821,895,005 people affected by floods between 1980 and 2009 (DEA 2011). The country is ill-prepared for the heavy summer rains that cause flooding in eight of the nine provinces. When dams overflow and rivers burst their banks, the government usually declares a state of disaster. In March 2014, the town of Bela Bela in Limpopo and surrounding areas were flooded when a dam wall gave way. Figure 1 shows flooding at the Coal mining Town of Lephalale in Limpopo Province, while Figure 2 shows flood waters and submerged houses at Port Alfred Town in October 2012.

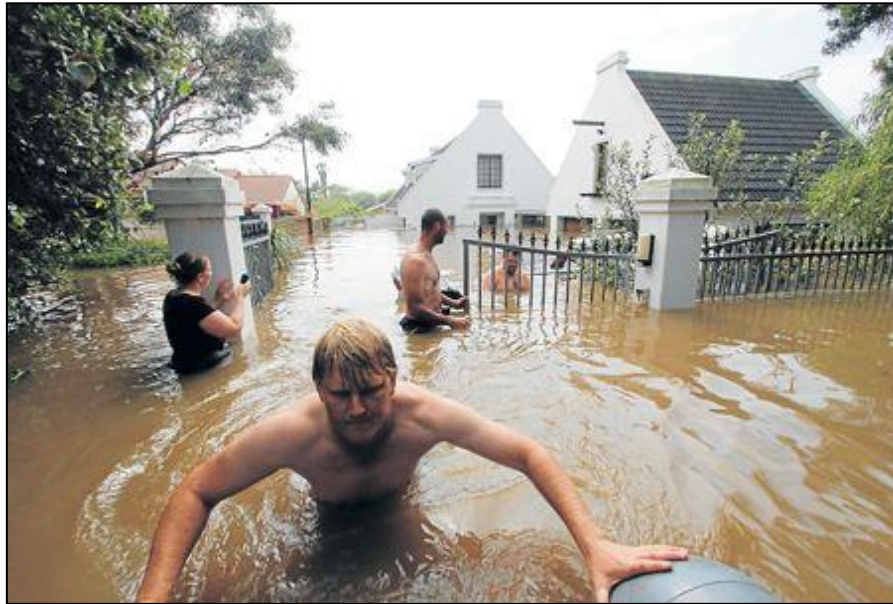
Figure 2: Floods in Port Alfred Town in Eastren Cape Province

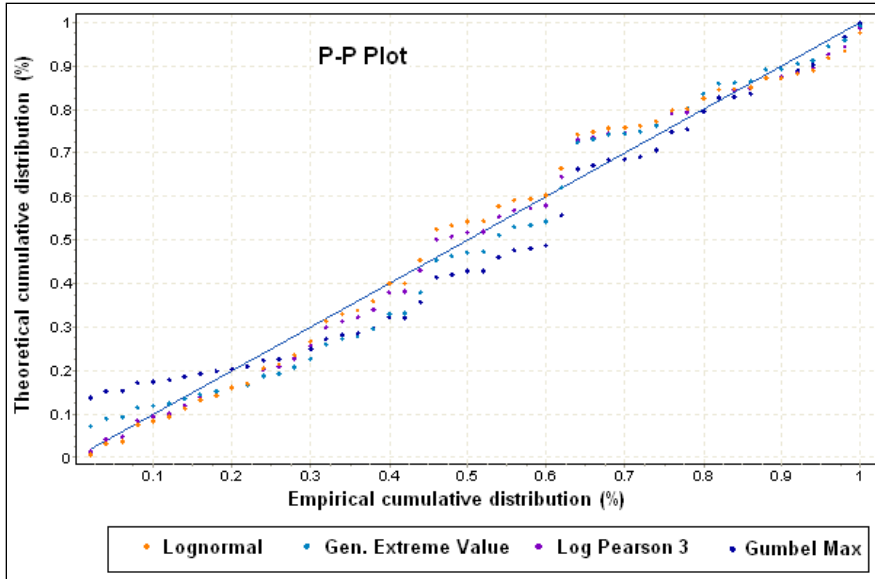
Figure 9: Probability-Probability plots

The linearity of the probability plot indicated the goodness of fit as shown in Figure 9. Given the rapid land use changes in the catchment, a significant rise in water levels would lead to an increase in potential flood damages, particularly for flood events of lower to medium extremity, reducing flood security for existing protection facilities. Figure 10 shows the probabilistic plot of return periods based on Gumbel's distribution for station A9H003 located in upstream of the catchment.

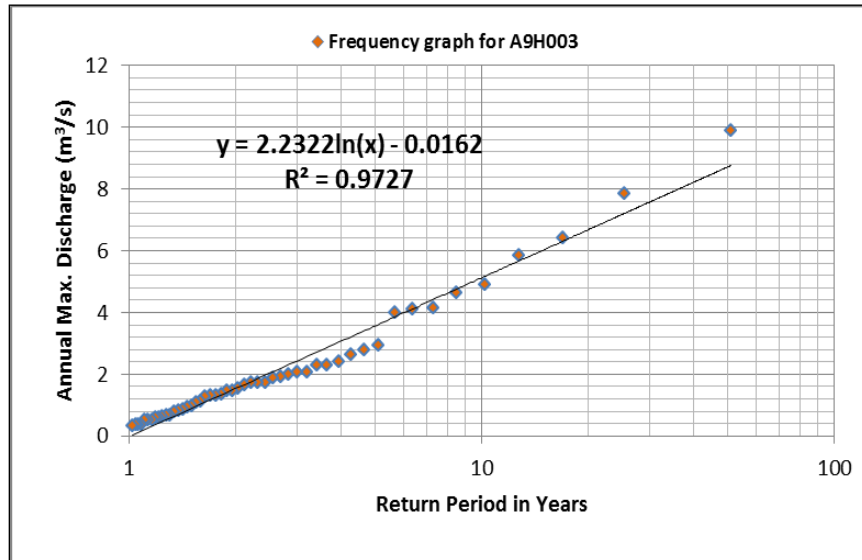
Figure 10: Probabilistic plot of return periods based on Gumbel's distribution

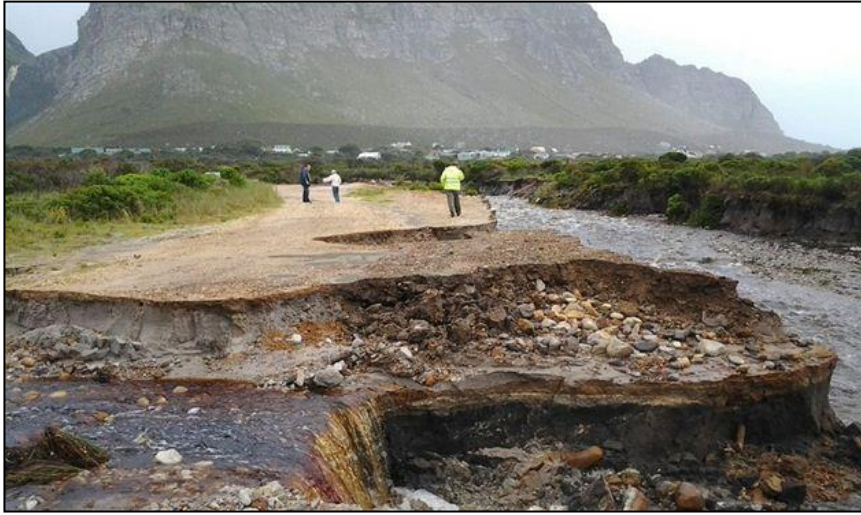
Figure 11: Road damaged by floods at Betty's bay

Heavy flood water caused damage to roads at Betty's bay and Chapman's peak as shown in Figure 11 and Figure 12 respectively. The flood water washed away part of the Sandspruit River in Zandspruit west of Hoedspruit in March 2014 and caused damage to access road to the Air Force Base at Hoedspruit as shown in Figure 13.

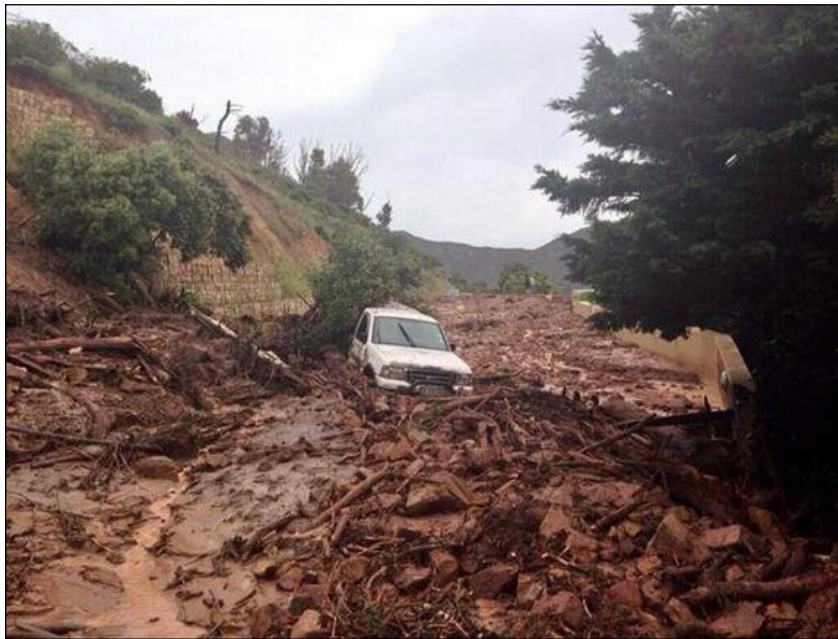
Figure 12: Road damage and debris at Chapman's

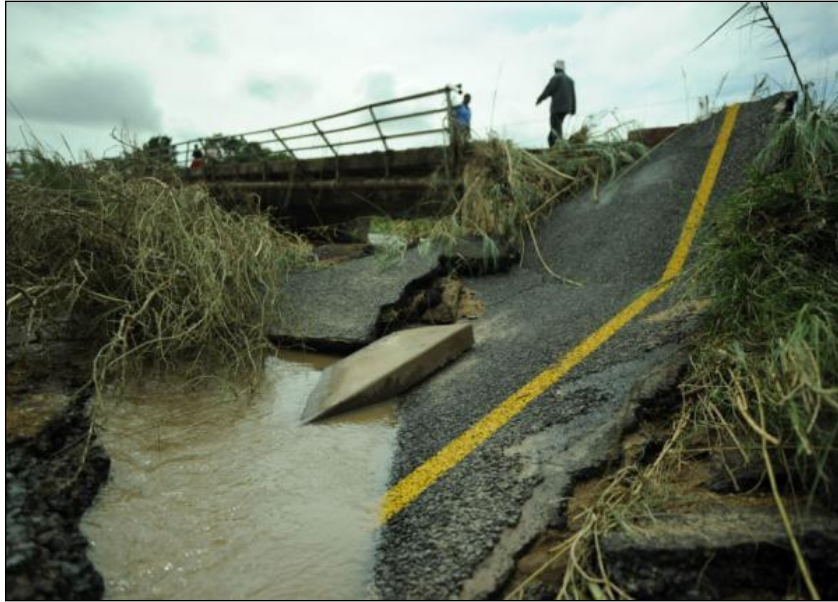
Figure 13(a): Road damage at Sandspruit River

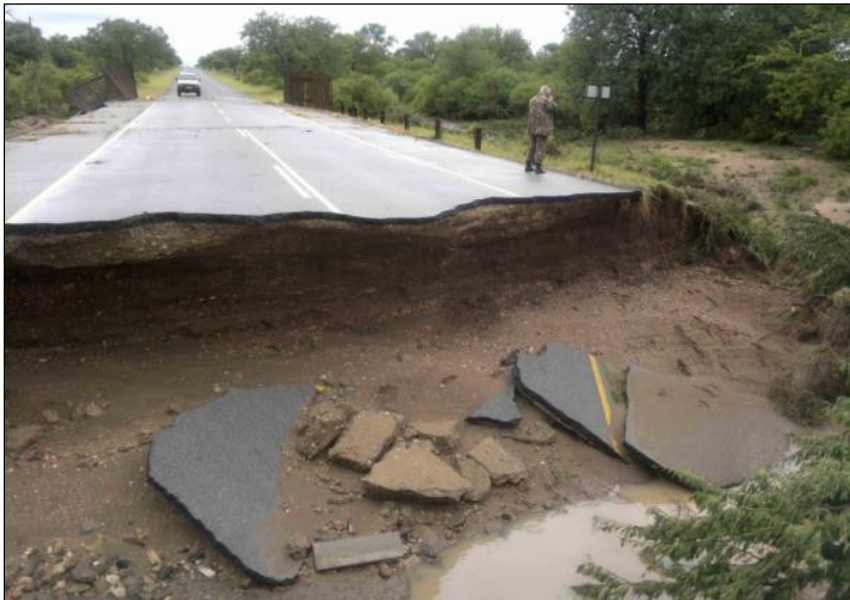
Figure 13(b) Road damage on access road to AFB Hoedspruit in Zandspruit
