ANALYSIS OF A ANTROPIC INFLUENCES IN A FLOODPLAN

M.C.S. Pereira^{1&2}; J.R.S. Martins¹; R.M. Lucci² and L.F.O.L. Yazaki²

Key Words: Floodplain, Water Bodies, Antropic Influence, Hydrodynamic Model

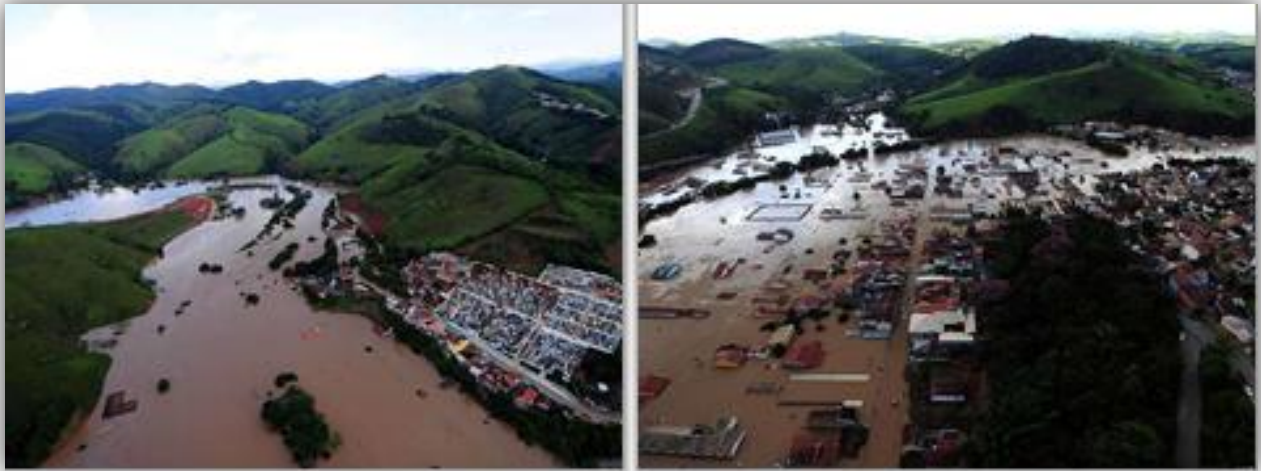
In this article an analysis of anthropogenic interference is in the larger bed of the Turvo River where posting send-outs are on its left bank. This analysis was motivated by the desire of the population of São Luís do Paraitinga, afraid with a possible change in the flow of rivers in the region, due to the disaster in the city in January 2010 caused by the passage of a historic flood, causing severe damage forcing the municipality to enact "State of Public Calamity." Damage caused by heavy rain in the floodplain of the river can be seen in Figure 1.

Figure 1 – São Luís do Paraitinga after rain in January of 2010. Source: Terra

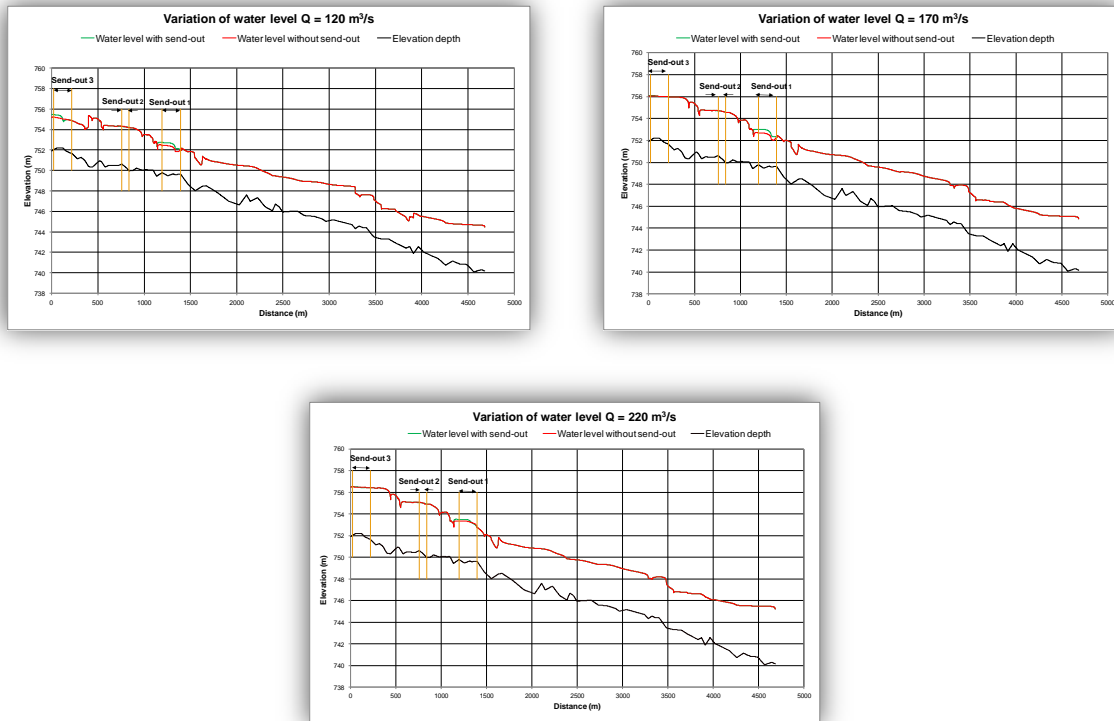
The results shows the waterline of the Turvo river in the stretch profiles studied, with and without the send-outs to the flow of $120 \text{ m}^3/\text{s}$, $170 \text{ m}^3/\text{s}$ and $220 \text{ m}^3/\text{s}$, as shown in Figure 5 below.

Figure 5 - Change of water level for flow of 120, 170 e 220 m^3/s , in analyze stretch.

It was found that there is a difference between the profiles of the water lines before and after the release of send-outs, which occurs mainly in the first 1500 meters of the river where human action with the disposal of land in the floodplain of Turvo river occurred. The biggest differences between water levels were 31 centimeters to the flow of 120 m³/s in sections 173 and 179; 35 centimeters for the flow of 170 m³/s in sections 173 and 179; and 17 centimeters for the flow rate 220 m³/s in section 179. Table 2 shows the results for the flow rate of 170 m³/s for which the largest differences occurred.

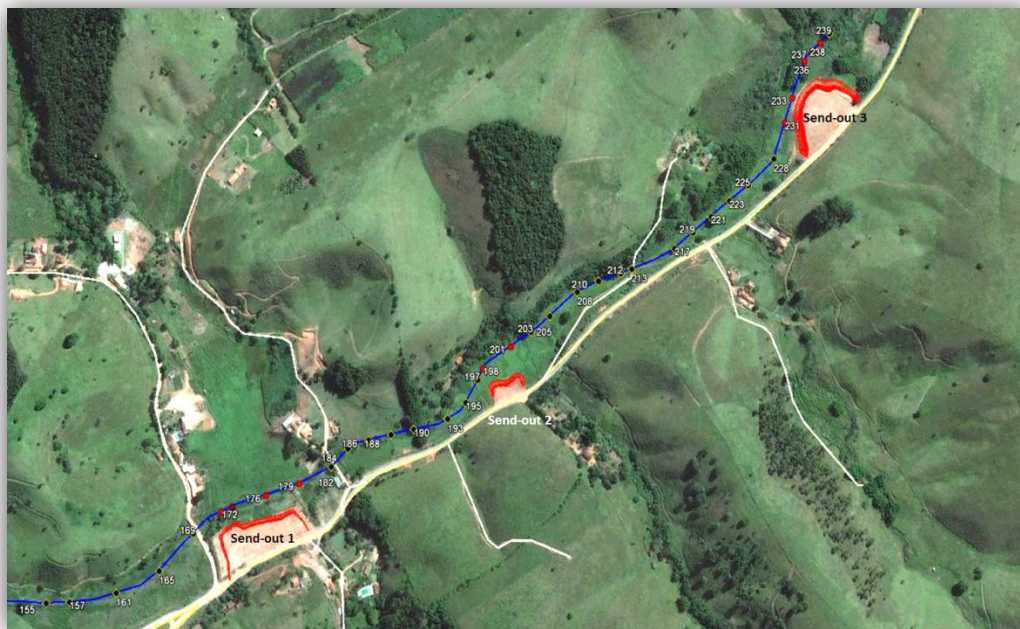
The Figure 6 shows the send-out localization and its sections.

Figure 6 – Location of send-outs and sections.

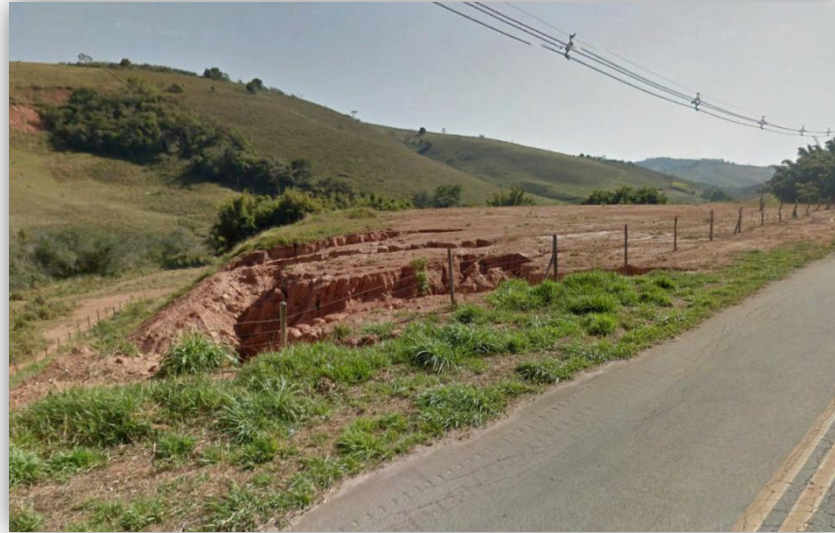
It is important to show that in some sections the velocity is above 1.5 m/s, which is the maximum velocity recommended by DAEE to ground channels. This send-outs were launched and maintained without protection, where ground are show without any protection erosion, some are critical velocities observed. Figure 7 below shows a picture of the Google Street View of September 2011 where erosion can be observed in the send-out 1.

Figure 7: Erosion in send-out 1
