QUALITATIVE DIAGNOSIS OF THE INFLUENCE OF SILTING ON URBAN FLOODS

B.H. Incau^{1&2}, S.B. Costa¹ and G.S. de Almeida Filho¹

1. Institute for Technological Research (IPT)
2. Federal University of ABC (UFABC)

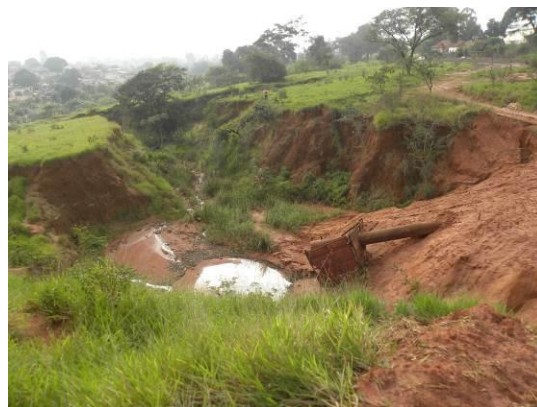
Figure 2 - Erosion ER-004 in June 2012.

Through photo interpretation of aerial imagery (EMPLASA, 2011), 8 significant gullies were identified, from which 4 were developed in the head of watercourses and the others in the hillslopes. The conditions found at the site, during the field survey (June 2012) are summarized at the following Table 1, followed by pictures of two of the erosions found.

It is noticed that most of the processes are related to areas with urban use and grazes without soil conservation practices. Also, most of the processes are likely to have been started by irregular discharges, which evidence the lack of appropriate techniques for drainage. The gullies have significant dimensions, up to 10m depth and 500m of extent, and are expected to keep in progress, providing considerable amounts of sediments to the downstream. Along the Grama stream, 7 deposits of sediments were found in the lower areas (such as the one shown at Figure 4).

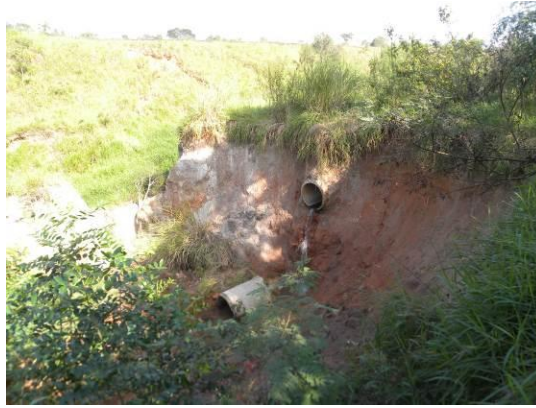
Figure 3 - Erosion ER-007 in June 2012.

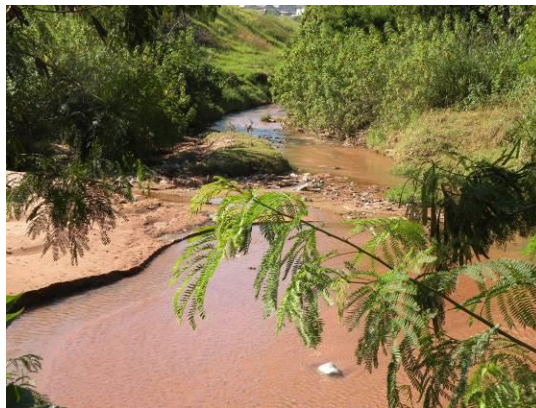
Figure 4 - Sediment deposit SD-006 in June 2012.

Respecting to the flood issues, the local Civil Defense and the population nearby the stream have reported flood issues at the lower course of Grama. It was observed that the floodplains are occupied, with houses distancing from 10 to 20 meters of the banks. The population had pointed mayor problems in the Comendador Daniel Pacifico Avenue, where a bridge is constraining the water flux, not only by its own structure, but especially by the silting of the stream bed, that reduced the cross section (next to the deposit shown on Figure 6).
